Project Case Study

Nyrstar Port Pirie Remedial Plinth Project SA

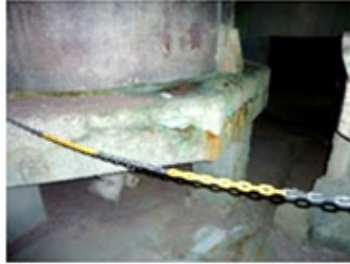
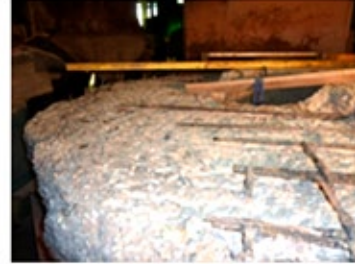
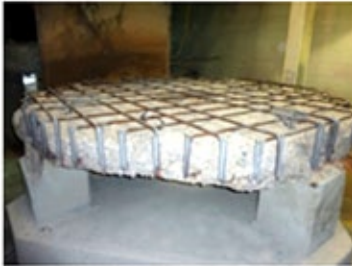
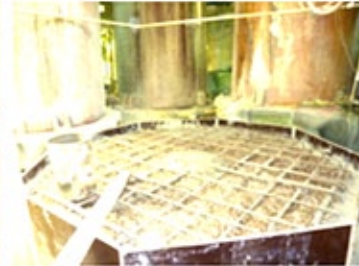
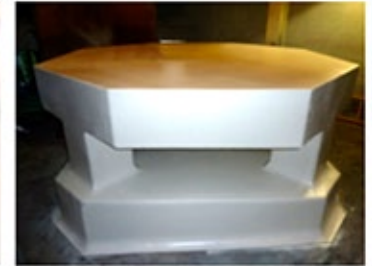
They had smelter reactor tanks leaking corrosive materials that severely damaged the concrete tank columns and bases. Poly-tech was brought in to assist in the decision to innovate or detonate.

Firstly we had to identify those areas along the tank column and tank base that required remedial repair. Grit blasting was then carried out to remove those cancerous and acid contaminated areas so we could prepare the structural steel reinforcements.

Secondly we reinstated the existing reinforcing plus included new reinforcing to a new concrete base that was boxed out approximately 150mm outside the the existing columns and approximately 300mm deep. Repairs we carried out to all exposed reinforcing by jack hammer and we applied 110 EpoCem bonding & Mono Top 615 HB cementious concrete repair mortar.

Finally the repaired areas were primed with Sikafloor 156 epoxy primer and poured N25 (20mm) to the aggregate concrete on the new base.
