# Project Case Study

## Port Pirie Remedial Plinth Project SA

## Project Summary

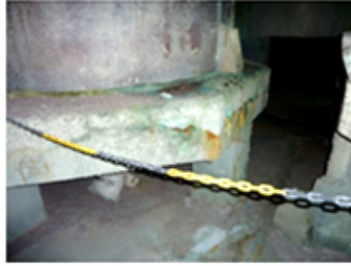
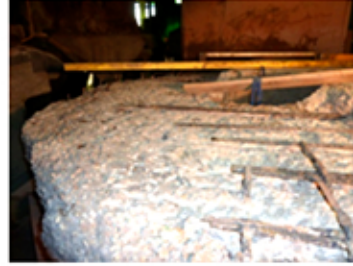
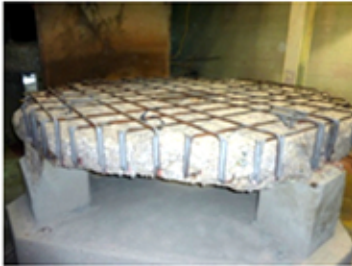
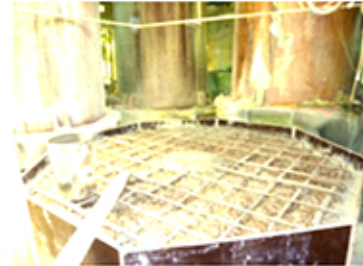
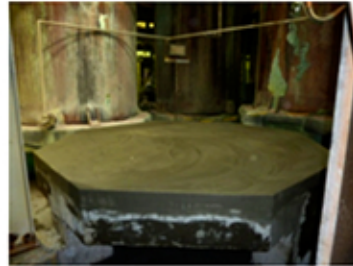
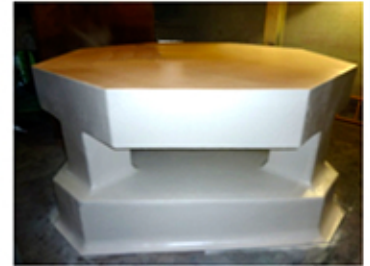
Smelter reactor tanks can leak corrosive materials that severely damaged concrete columns and bases. Poly-tech was brought in to assist in the decision to innovate or detonate.

Firstly we had to identify those areas along the tank column and tank base that required remedial repair. Grit blasting was then carried out to remove those cancerous and acid contaminated areas so we could prepare the structural steel reinforcements.

Secondly we reinstated the existing reinforcing plus included new reinforcing to a new concrete base that was boxed out approximately 150mm outside the the existing columns and approximately 300mm deep. Repairs we carried out to all exposed reinforcing by jack hammer and we applied 110 EpoCem bonding & Mono Top 615 HB cementious concrete repair mortar.

Finally the repaired areas were primed with Sikafloor 156 epoxy primer and poured N25 (20mm) to the aggregate concrete on the new base.
