Project Case Study

**Australian
Fruit
Mildura**

Concrete Stabilisation & Injection

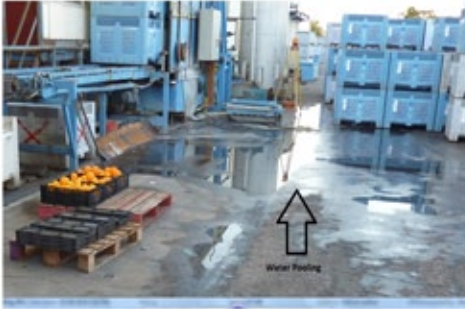
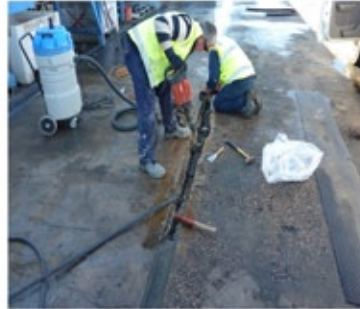
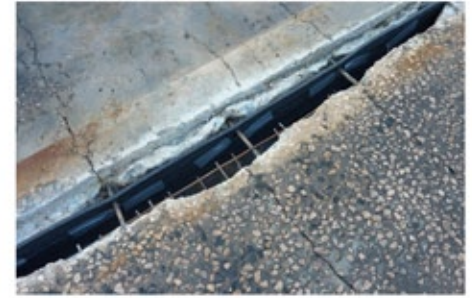
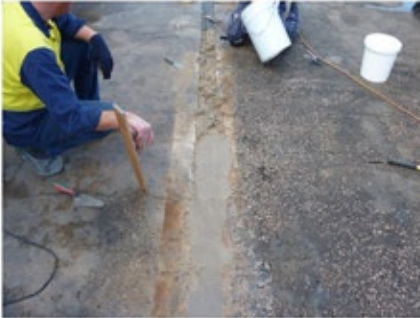
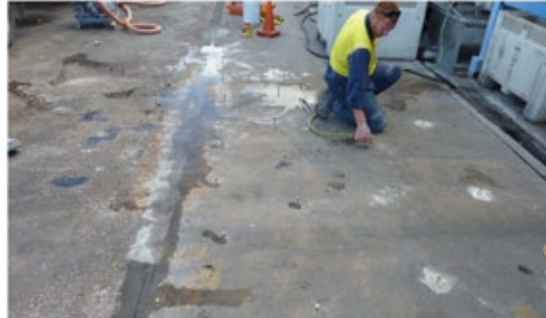
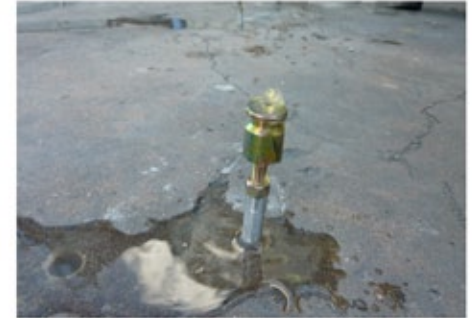
Australian Fruits had real concrete issues with their high traffic unloading area. The everyday task of manoeuvring corrosive fruits by forklifts and pallet bins caused the concrete slabs to sink resulting in water ponding and egressing down the control joints.

1. Careful removal of damaged and separated concrete along the affected joint.
2. Use of expansion foam to recreate the control joint to reinstate the sides of the joint using specified epoxy mortar mix with a trowel finish.
3. Drill and inserted injection plugs to a specialised grid system.
4. Inject water in to the plugs to establish a steady water flow through the system.
5. Once flow established, convert to injecting resin which reacts with the water resulting in foam formation which stabilizes the slab by replacing the water in the substrate with foam.
6. Cut control joint, insert backing rod and fill with polyurethane joint sealant.

The result. The slab lifted & levelled correctly totally removing water ponding problems.
