Project Case Study

Hungry Jacks

Project Summary

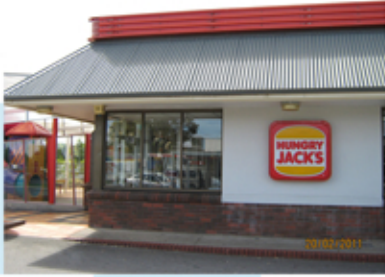
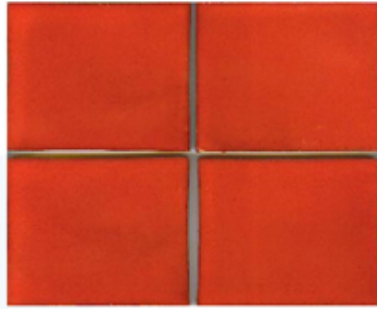
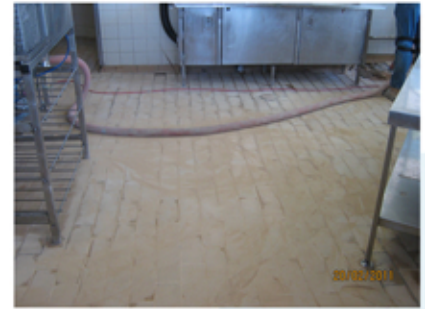
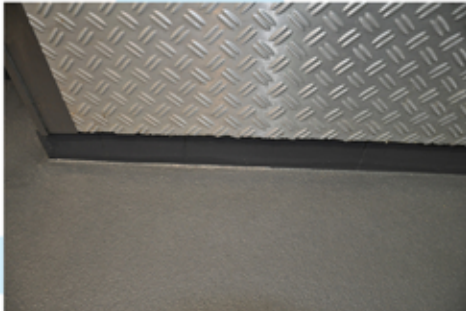
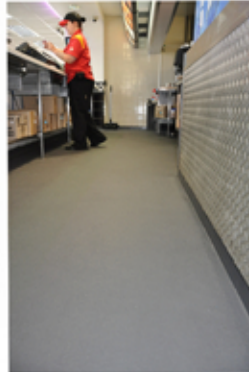
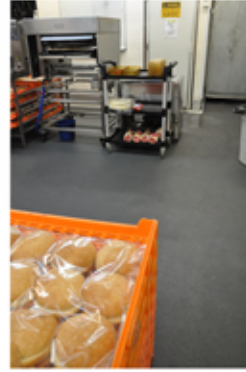
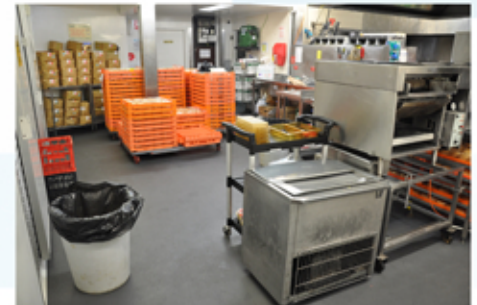
Hungry Jacks Elizabeth contacted Poly-Tech as isolated areas of their tiled floor became loose, drummy and slippery so caused safety issues with staff.

Preparation began with grinding the old tiles followed by the detailing around the drains and the perimeter grading. Repairs were also made to loose and drummy tiles prior to laying. The final installation consisted of a 5mm non slip polyurethane system and a final seal coat in the desired colour resulting in a cost-effective and reliable solution for all areas of store.

Instead of re-tiling the whole store meaning loss of trade and significant additional costs for new tiles, a polyurethane system was specified which enabled the kitchen area to be completed within a very quick turnaround (3 days), was seamless for easy cleaning, free of grout lines that can harbour bacteria, provide an excellent slip resistance, had heat & fat resistance and was cost effective.
