Project Case Study

Flinders University

Sturt Road
Bedford Park SA 5042

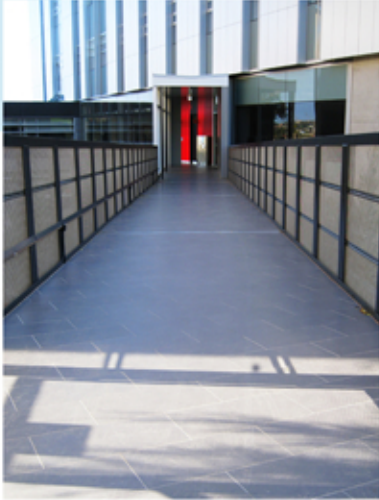
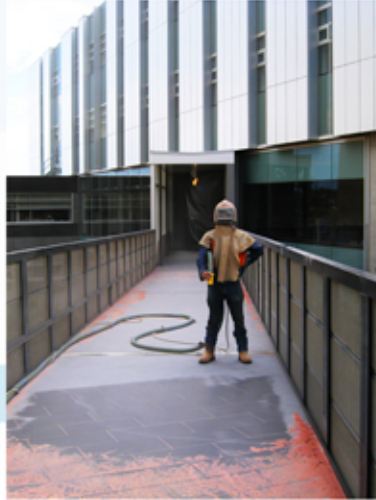
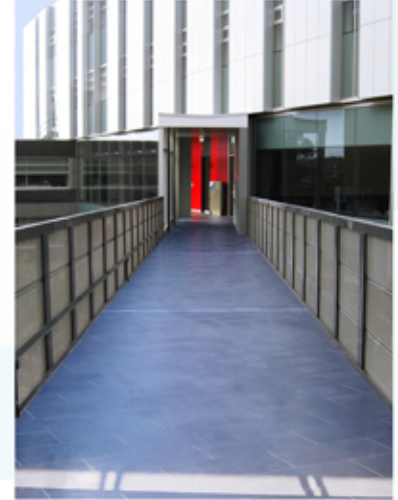
During the design stage of the new science building at Adelaide's Flinders University, budgetary restraints resulted in the project having to be scaled back, consequently a previously covered walk way was left exposed to the elements. The original tiles selected for the project did not meet the minimum slip resistance of the Australian Standards based on AS/NZS 4586. Following hand over of this award winning building it became apparent that the need for some form of non slip treatment was urgently required to meet OH&S standards. Given the emphasis placed on the aesthetics of the building it was necessary to find a solution which met the needs of all parties.

Poly-Tech were consulted to undertake trialling of several options to rectify the problem. It was immediately apparent that any form of surface applied non slip coating would dramatically distract from the overall appearance and provide a less than satisfactory outcome. The method finally selected which met all the clients' requirements was to mechanically abrade the tiles to the required slip rating. This process is performed on site with minimum disruption and provides a visually appealing transition from one surface to another.

In conjunction with the builder Hindmarsh the sample tiles were provided and treated off site and sent for testing at a registered laboratory. The results of which far exceeded expectations and was given a 'V.AV' classification which denotes a 'very low' risk of slipping when wet. These results were provided to the client and Poly-Tech was contracted to carry out the work over a weekend period.

The mechanical abrasive process was performed to a standard of the control tile retained from the testing. The tiles were then treated with a penetrating sealer to protect against staining and provide for ease of cleaning.
