# Project Case Study

### Tusmore Park Wading Pool

Stirling Street  
Tusmore Park SA

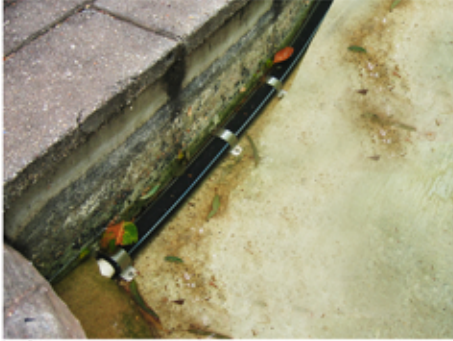
before

When Poly-Tech Industrial Services came to inspect the pool, the concrete substrate was pitted and cracked and the existing coating has failed which can lead to algae imbedding itself into pores and crevices where it can harbour and foster bacterial growth.

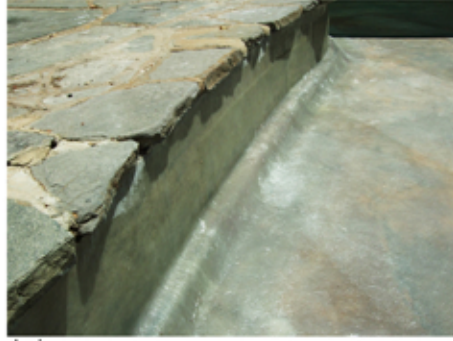
during

Firstly the total removal of the previous coating and the grinding of the concrete was in order to ensure 100 percent adhesion of the new system. Remedial repairs were needed to remove drummy concrete, grinding back the reinforcing steel to remove rust, treat with anti-corrosives and make good the render to restore the original facade.

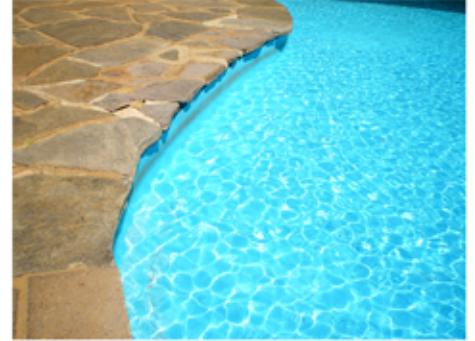
after

The new covering of fibreglass is structurally strong, has a waterproof barrier, prevents and covers unsightly surface cracks and reduces water loss through leaks. It is quick to install, has an ease of maintenance and coated with a non slip gel coat that resists algae growth.

Aesthetically the Tusmore Park wading pool has been instantly improved. The all important environmental issues of water leakage solved, and the health and safety of the children assured.
