PROJECT SUMMARY

Poly-Tech Bridge & Water
Crossing Solutions
State Infrastructure

Patawalonga Weir Gates

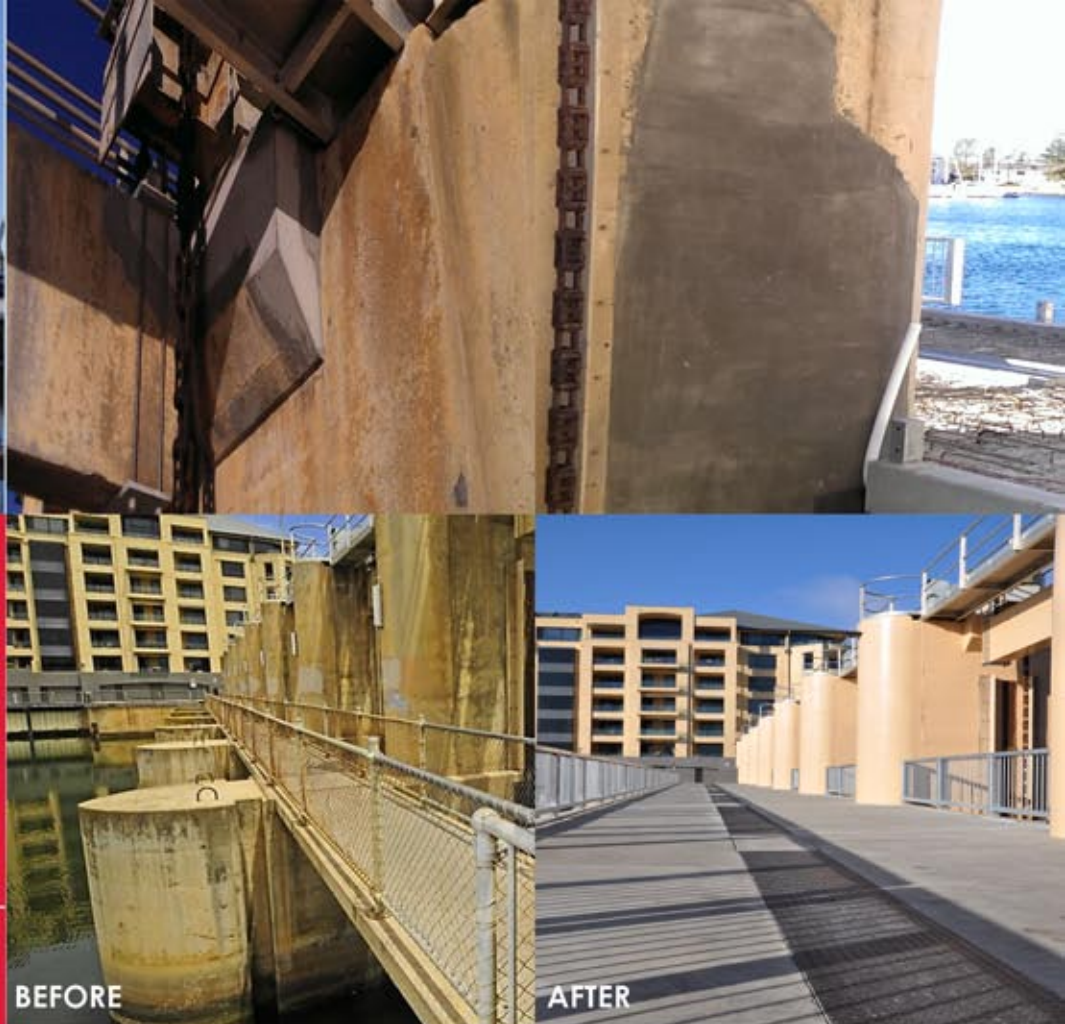
The project involved repairs to cracked, broken and spalling concrete using Renderoc HB70 wet spray system. This was carried out with first using a 4000 psi pressure wash followed by a self contained diesel driven spray pump to achieve a smooth and attractive trowel finish.

The protective coatings included the application of Ceilcote 680, Interplus 356 and Interfine 878 (Akzo Nobel Products)

The end result was an attractive and functional weir structure suitable for both pedestrians and cyclists.
